# Manhole Inspection Summary

Manhole # S25AA1004MH

Insp Date: **1/30/07 10:12 AM**

**Location** Address: **3522 BUENA VISTA AVE**

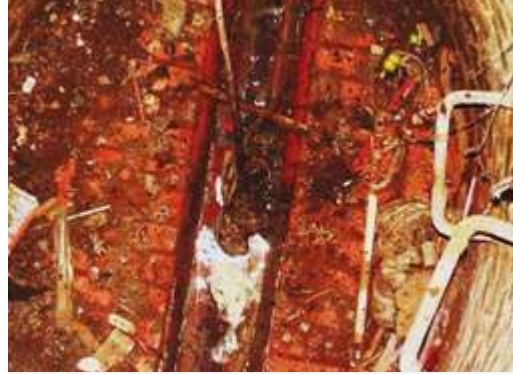
Top View

☒ **Debris** (not Condition related)

Condition: ☐ Sound ☐ Cracked ☐ Root Intrusion ☒ **Deteriorated** ☐ Leaks ☒ **Debris**

Bench and Channel debris.

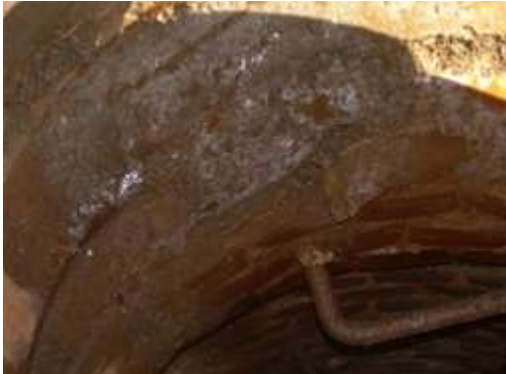
Defect

☒ **Leaks**

Condition: ☐ Sound ☐ Cracked ☐ Root Intrusion ☐ Loose Brick ☒ **Deteriorated**

Infiltration: ☐ None ☒ **Joint** ☐ Cracks ☒ **Mortar** ☐ Roots ☐ Wall

Frame leaks. Adjustment deterioration and infiltration.

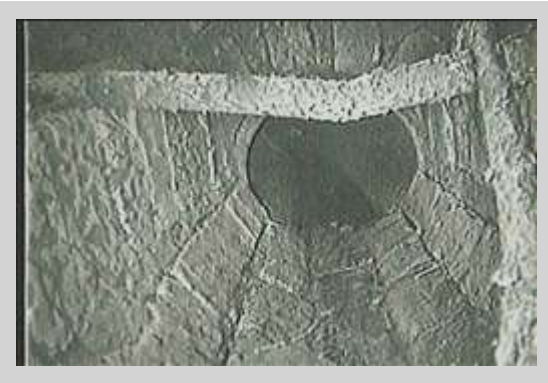
### 8 in. Circular Gravity Sewer Pipe Out @ 12 O'Clock

Channel deterioration.
